**Project Name & Address:**  
 Nhill Caravan Park

**Drawing Title:**  
 Existing Conditions Plan

Drawing Title:  
**Landscape Master Plan**

# Nhill Caravan Park

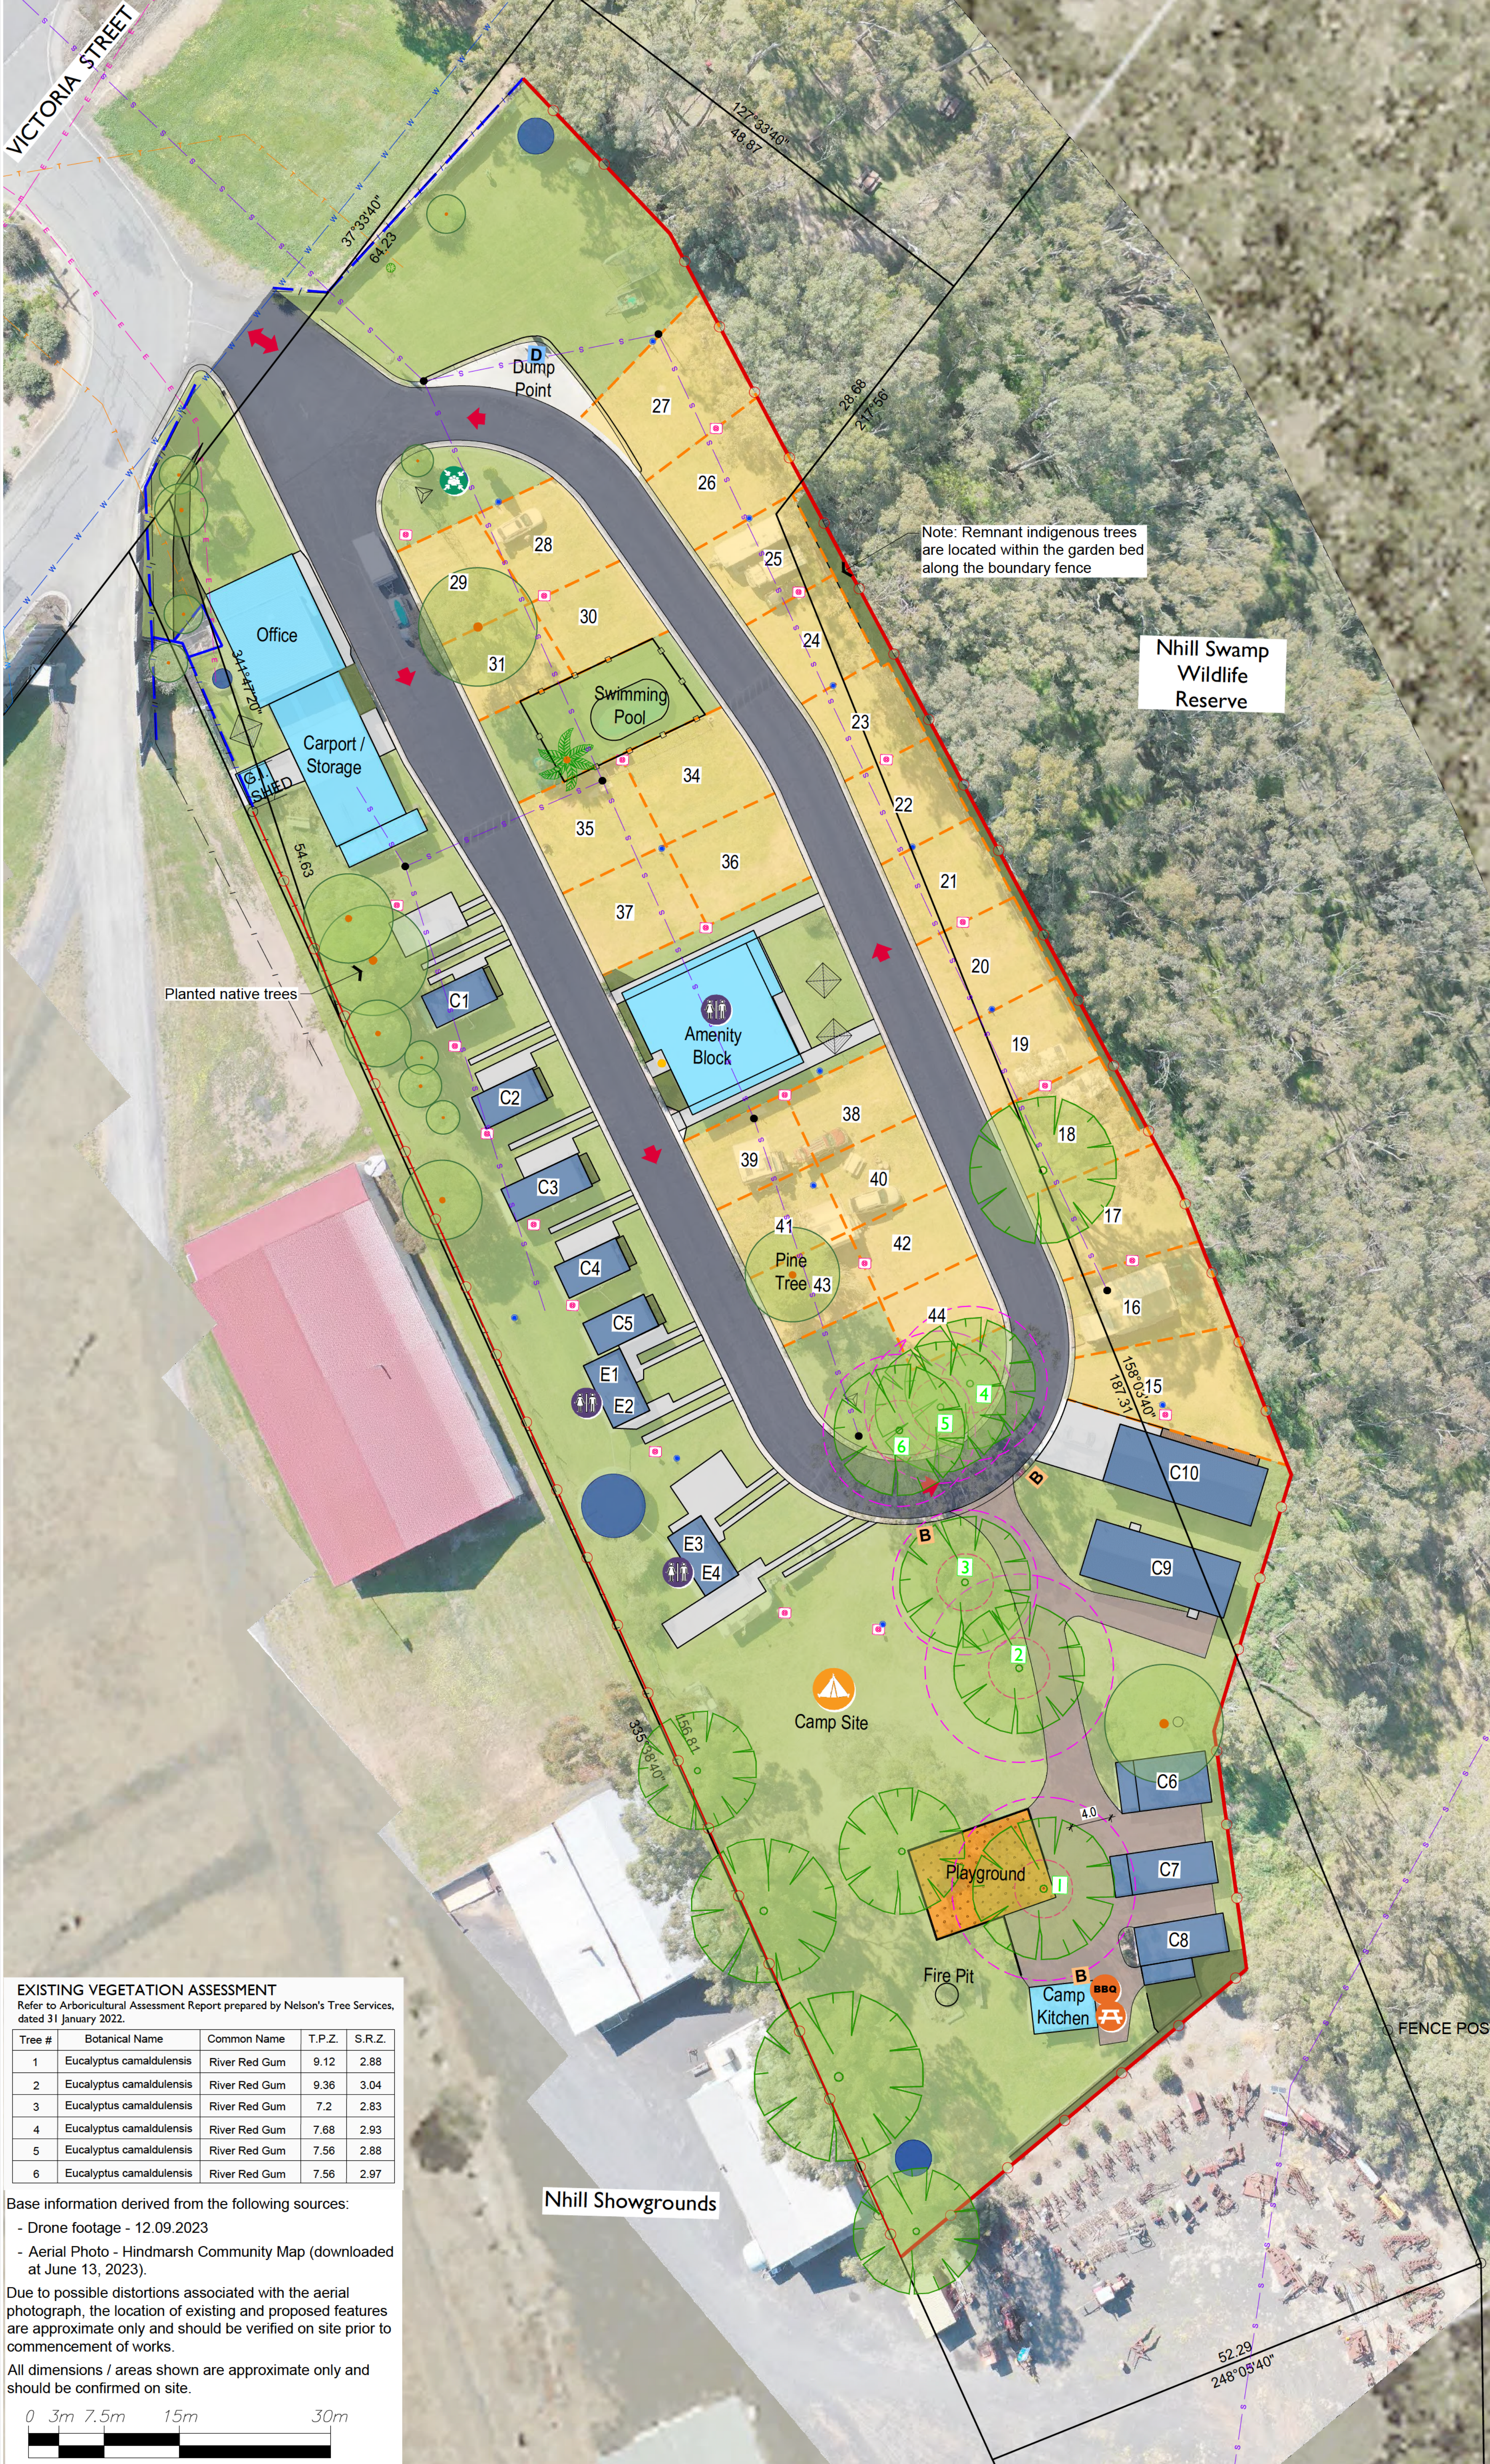
**EXISTING VEGETATION ASSESSMENT**  
 Refer to Arboricultural Assessment Report prepared by Nelson's Tree Services, dated 31 January 2022.

Base information derived from the following sources:  
 - Drone footage - 12.09.2023  
 - Aerial Photo - Hindmarsh Community Map (downloaded at June 13, 2023).  
 Due to possible distortions associated with the aerial photograph, the location of existing and proposed features are approximate only and should be verified on site prior to commencement of works.  
 All dimensions / areas shown are approximate only and should be confirmed on site.

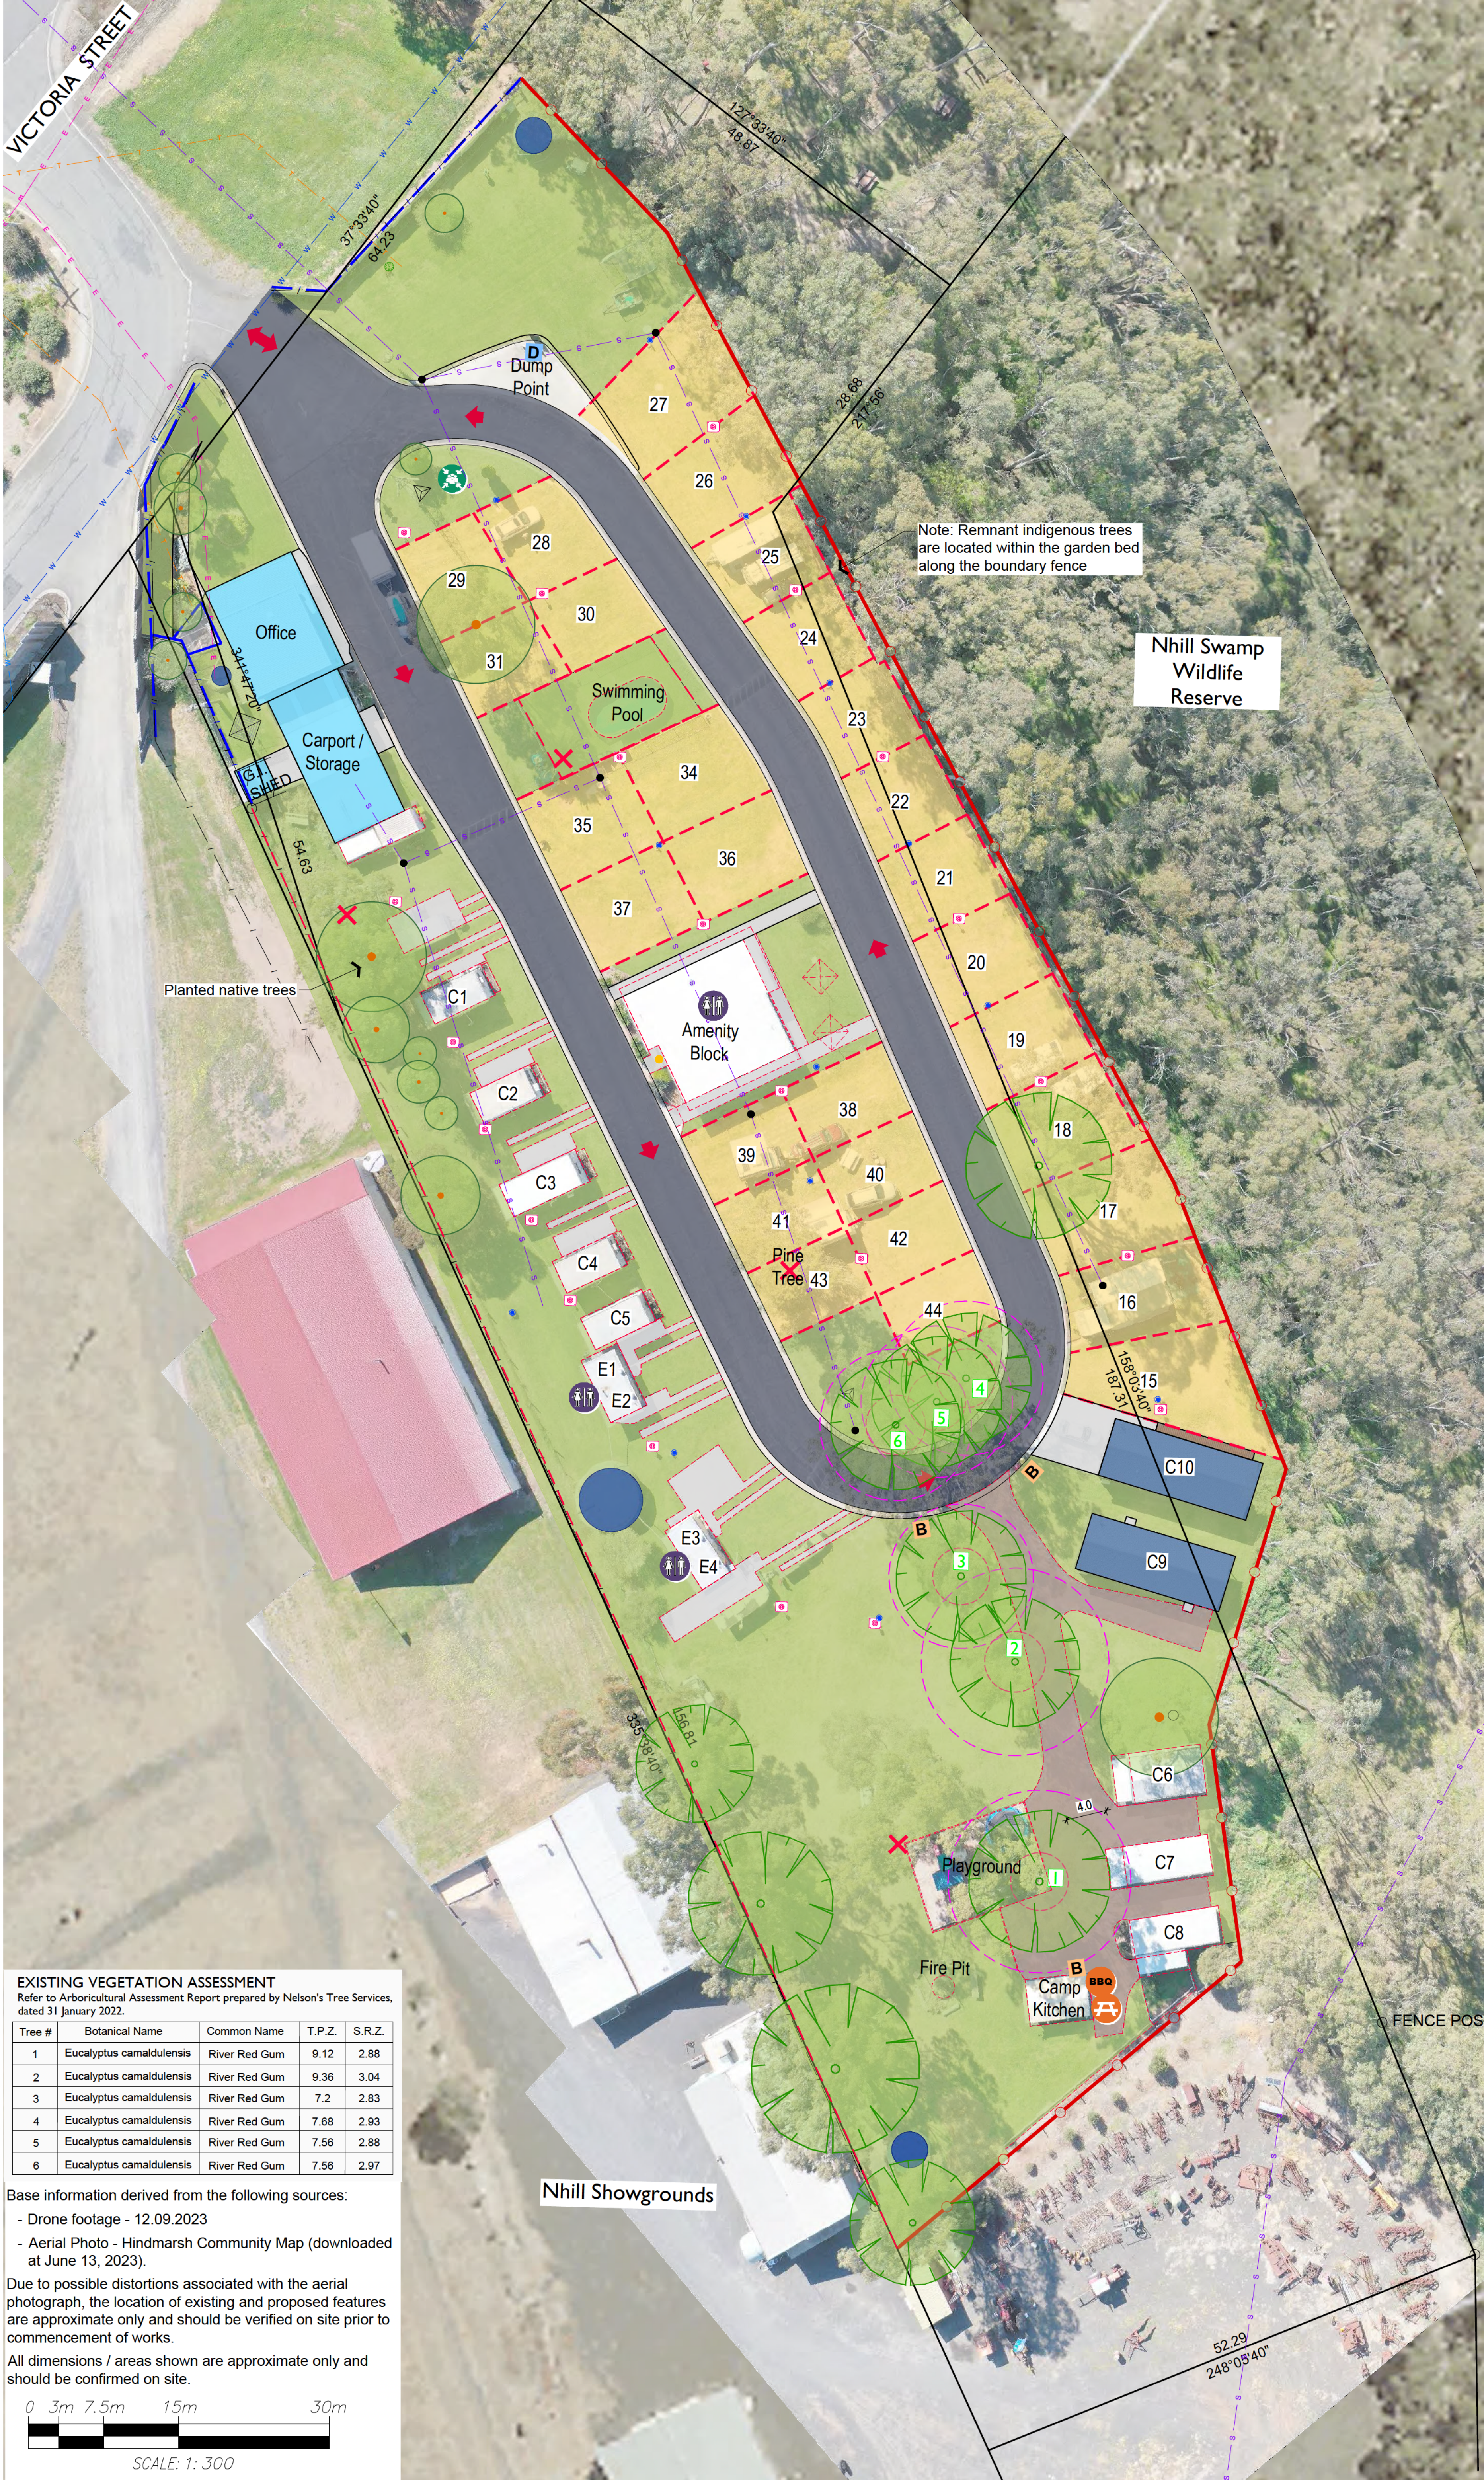
Drawing Title:  
**Demolition Plan**

Note: Remnant indigenous trees are located within the garden bed along the boundary fence

**EXISTING VEGETATION ASSESSMENT**  
 Refer to Arboricultural Assessment Report prepared by Nelson's Tree Services, dated 31 January 2022.

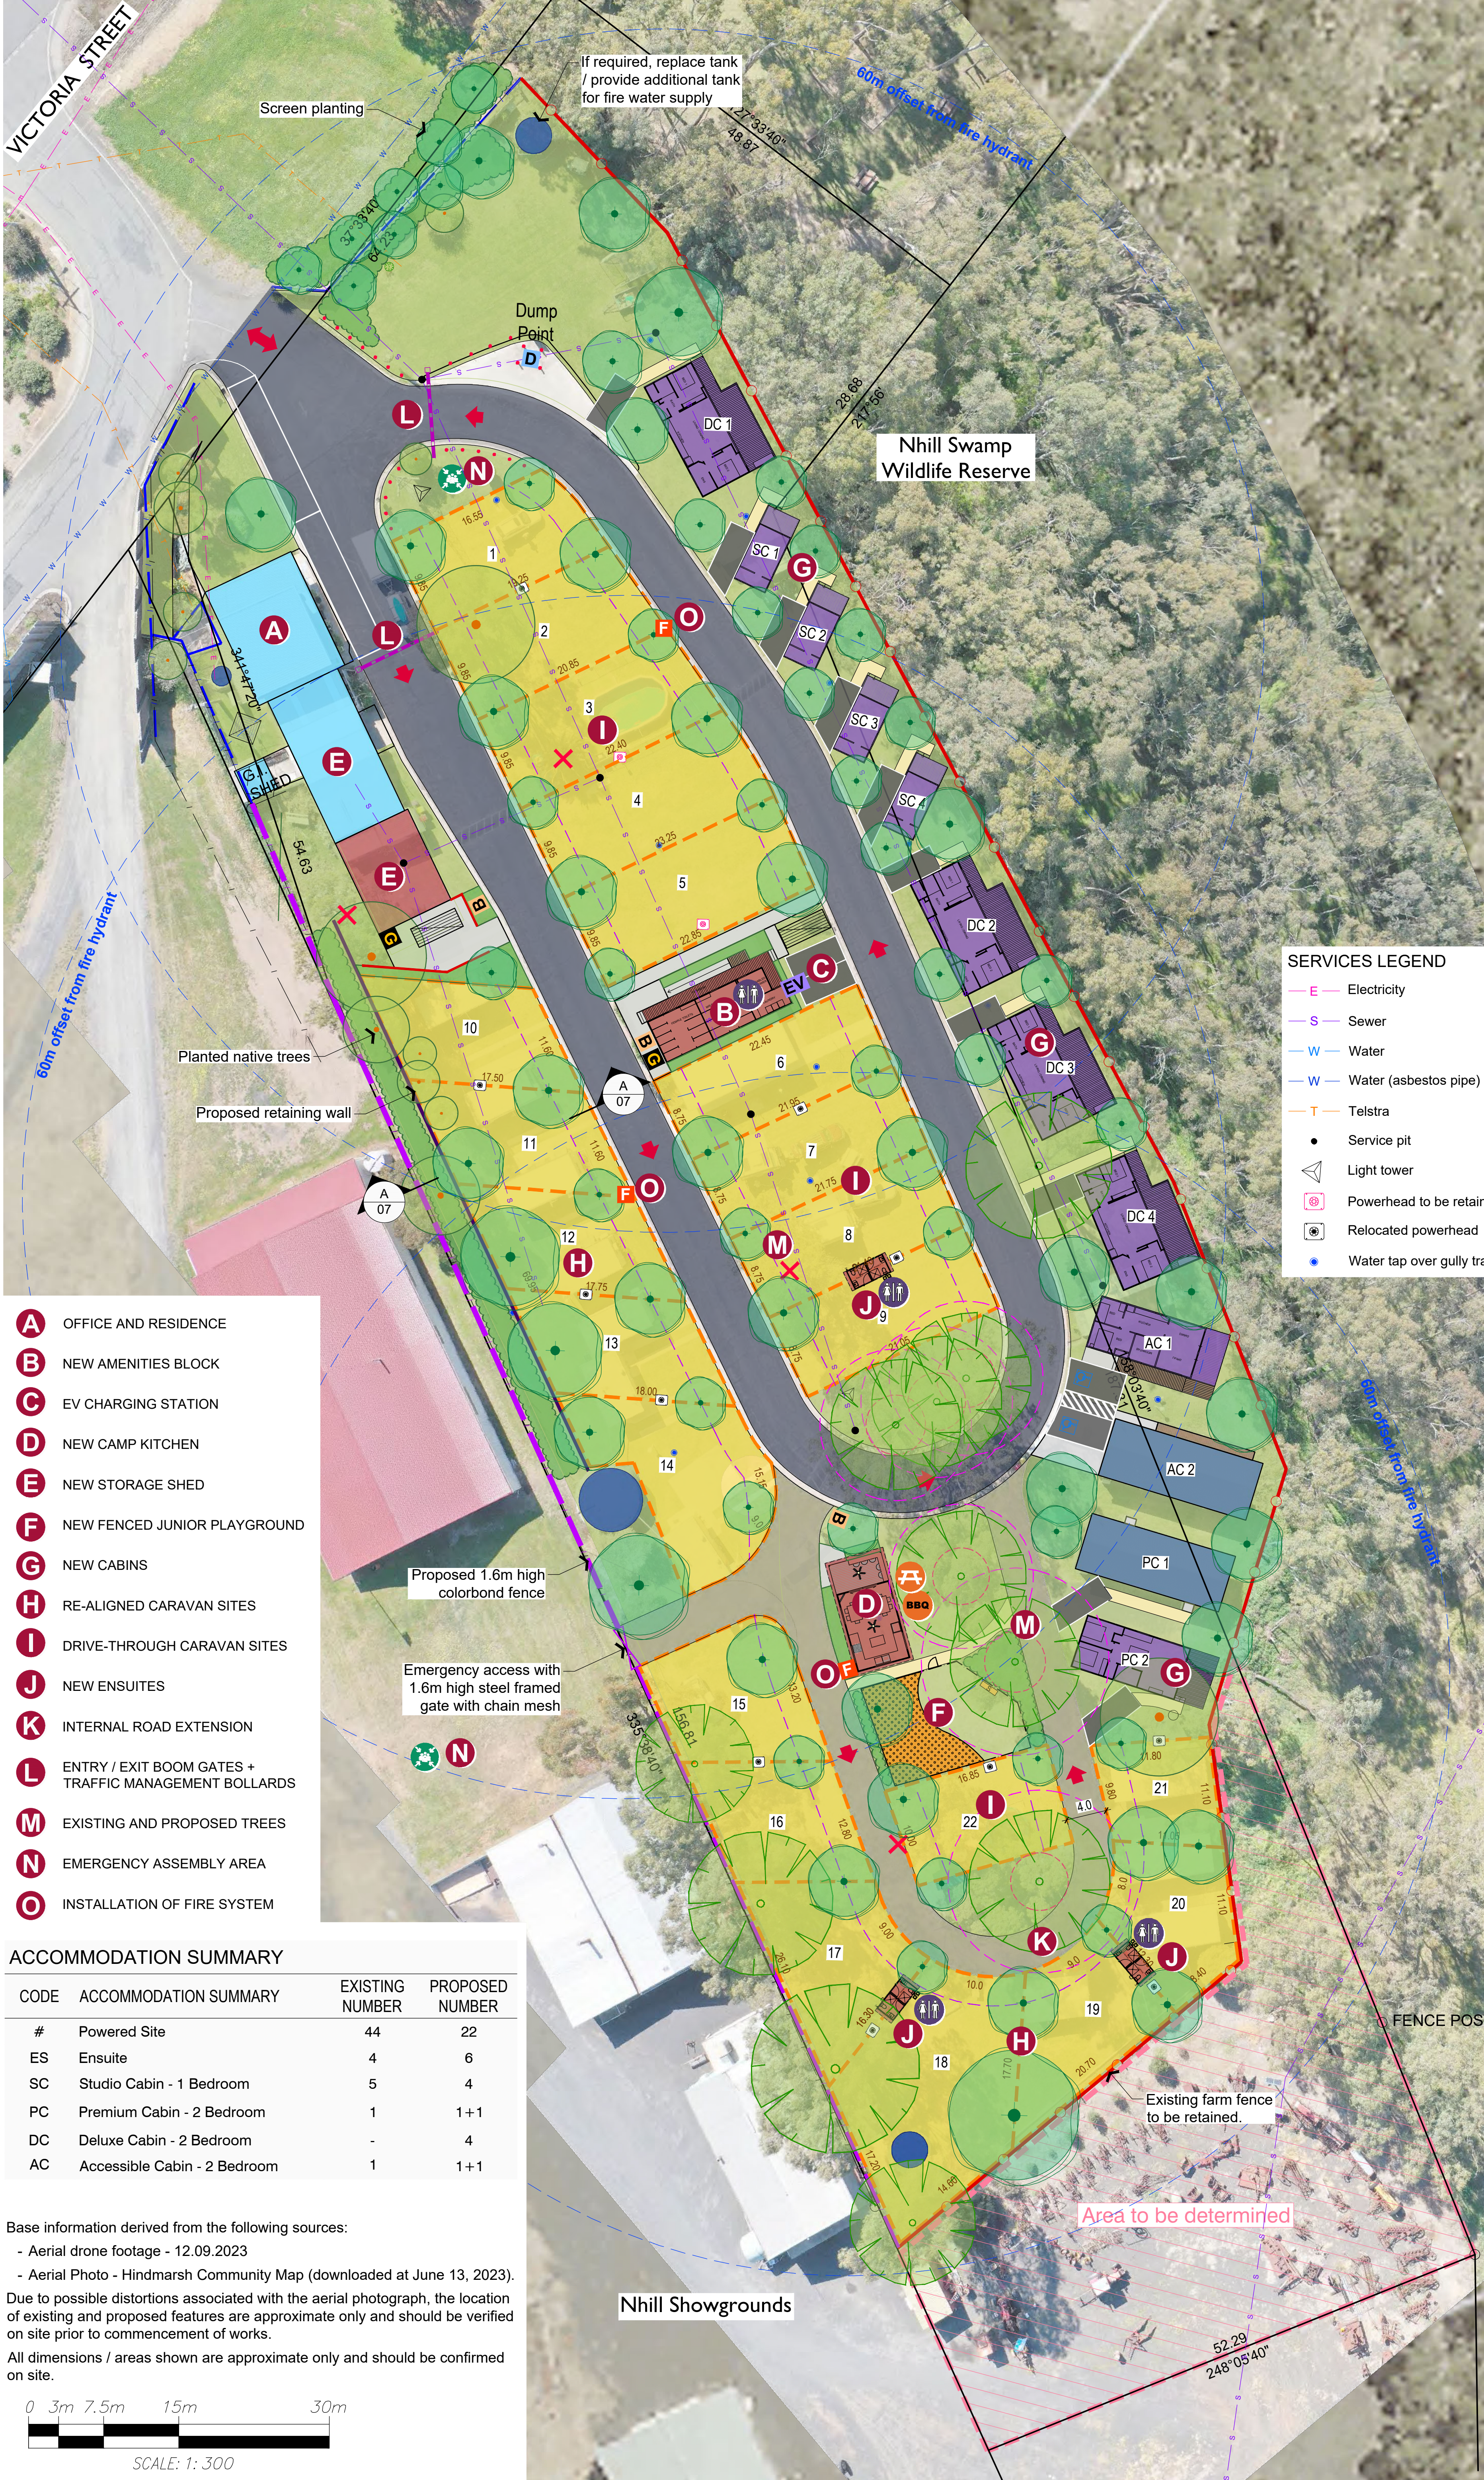
- A** OFFICE AND RESIDENCE
- B** NEW AMENITIES BLOCK
- C** EV CHARGING STATION
- D** NEW CAMP KITCHEN
- E** NEW STORAGE SHED
- F** NEW FENCED JUNIOR PLAYGROUND
- G** NEW CABINS
- H** RE-ALIGNED CARAVAN SITES
- I** DRIVE-THROUGH CARAVAN SITES
- J** NEW ENSUITES
- K** INTERNAL ROAD EXTENSION
- L** ENTRY / EXIT BOOM GATES + TRAFFIC MANAGEMENT BOLLARDS
- M** EXISTING AND PROPOSED TREES
- N** EMERGENCY ASSEMBLY AREA
- O** INSTALLATION OF FIRE SYSTEM

CODE	ACCOMMODATION SUMMARY	EXISTING NUMBER	PROPOSED NUMBER
#	Powered Site	44	22
ES	Ensuite	4	6
SC	Studio Cabin - 1 Bedroom	5	4
PC	Premium Cabin - 2 Bedroom	1	1+1
DC	Deluxe Cabin - 2 Bedroom	-	4
AC	Accessible Cabin - 2 Bedroom	1	1+1

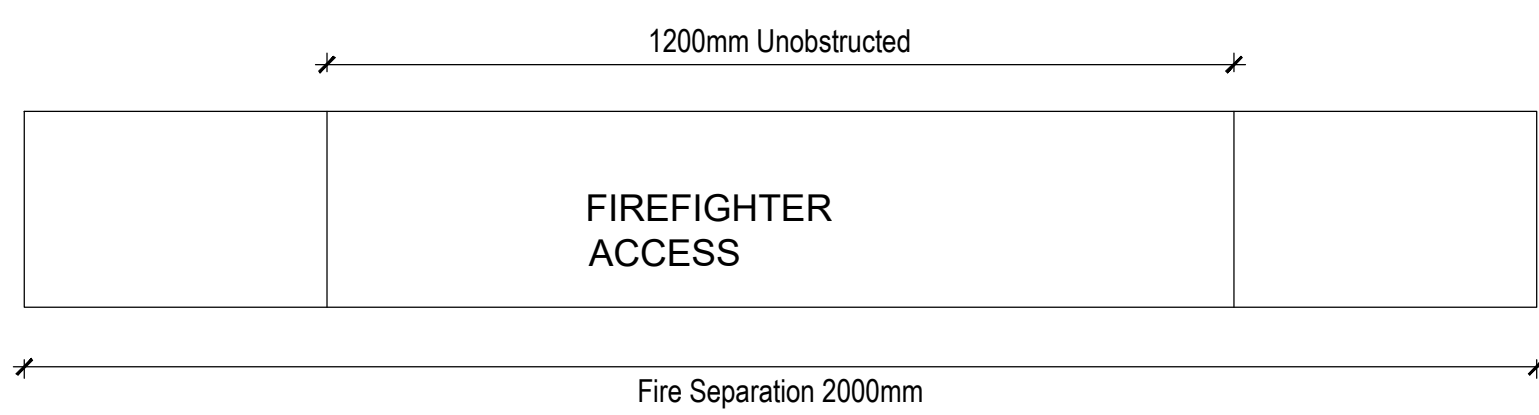
**FIREFIGHTER ACCESS AND FIRE SEPARATION**  
 Not to Scale

The minimum width required for firefighter access and fire separation must be provided between and around each structure in the caravan park in accordance with the following requirements as illustrated below.

**NOTE:**  
 The minimum width required for firefighter access and fire separation must be provided between and around each structure in the caravan park in accordance with the following requirements as illustrated below.

- 1200mm in width and unobstructed at all times. (It is preferred that the firefighter access width is centrally located, but this is not essential); and
- provide with a surface that is suitably trafficable

Fire separation must be 2000mm in width, measured between the external walls of associated structures. A minimum height of 2100mm must be maintained throughout the required fire separation width. Vegetation and storage between and around structure that may contribute to fire spread should be reduced and maintained appropriately.
